Subject: Cooling Tower Fan: Vibration Analysis and Mechanical
Inspection.
Nevada Power Company Purchase Order No. 28462
MEZCO Corporation Project No. Z85-010

"COOLING TOWER FAN"
"VIBRATION ANALYSIS AND MECHANICAL INSPECTION"

Prepared for:
NEVADA POWER COMPANY
Reid Gardner Station
Moapa, Nevada

Report Date: April 22, 1985

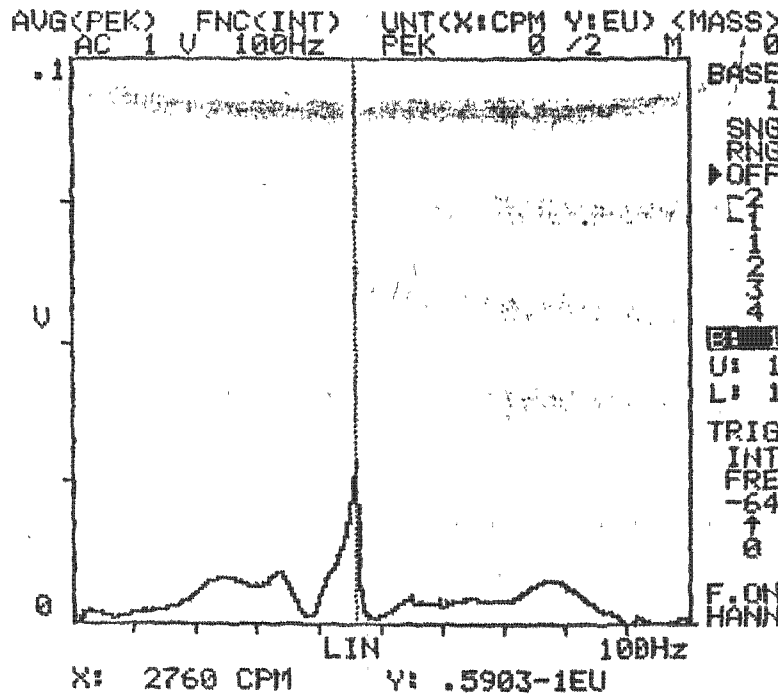
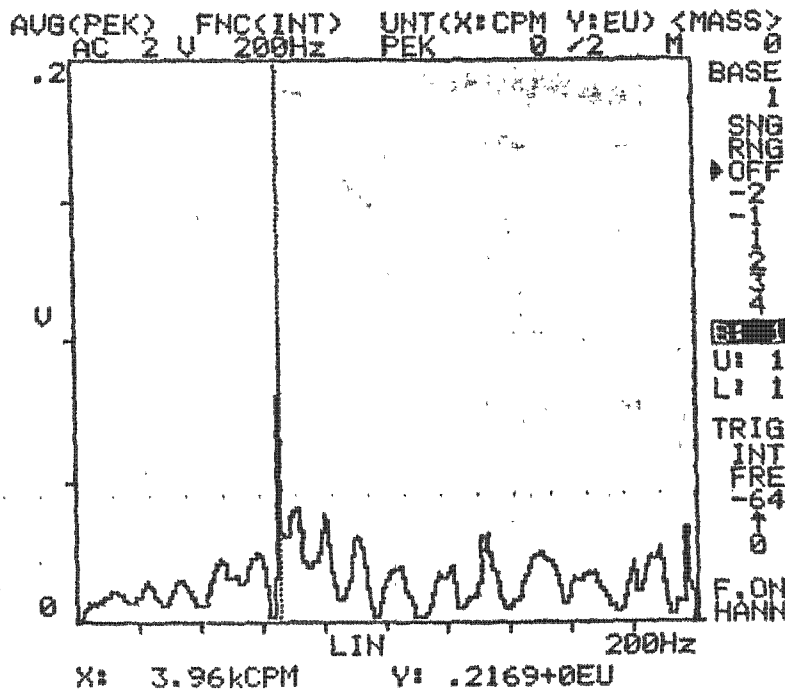
CLIENT NEVADA POWER COMPANY LOCATION REID GARDNER PLOT 1
 NUMBER _____ MACHINERY COOLING TOWER DRIVE SHAFT

4.1 DRIVE SHAFT NATURAL RESONANCE TEST Plot no. 1

Both drive shafts were tested for their natural resonances by exciting the shaft with a rubber mallet.

The 5 inch drive shaft natural resonance = 2760 cpm
The 4 inch drive shaft natural resonance = 3960 cpm

Both of the shaft's natural resonances are well above the running speed of the motor.

Date: APRIL 8, 1985
 Time: 08:58
 Machine: 1st shaft
 Loc: _____
 I.P.S. .059
 Mills _____ Deg _____
 Remarks: NATURAL
RESONANCE OF SHAFT
2760 cpm

Date: APRIL 8, 1985
 Time: 09:15
 Machine: 2nd shaft
 Loc: _____
 I.P.S. .21
 Mills _____ Deg _____
 Remarks: NATURAL
RESONANCE OF SHAFT
3960 cpm

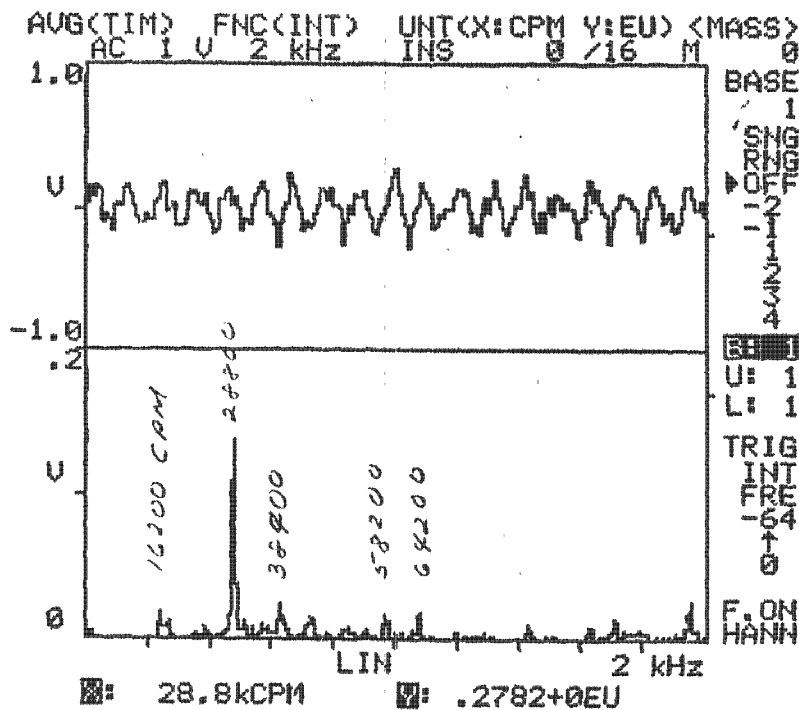
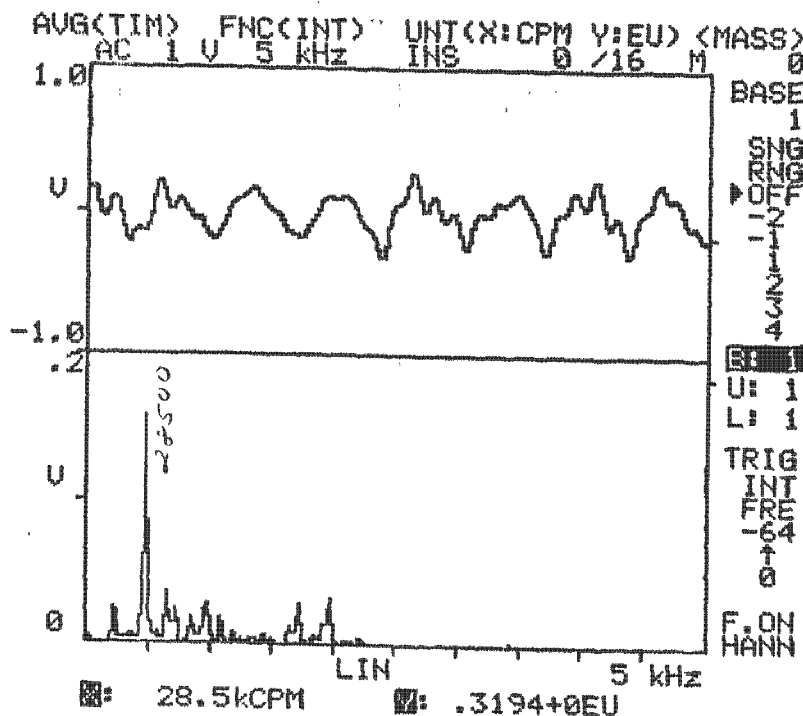
CLIENT NEVADA POWER COMPANY LOCATION REID GARDNER PLOT 2
 NUMBER NO. 4D MACHINERY COOLING TOWER FAN

4.2 COOLING TOWER FAN: CELL "D" Plot no. 2

Cell "D's" drive shaft was aligned within the acceptable limits, however, no movement between the center support bearing and the No. 2 drive shaft was made since the center support bearing housing was bolt bound and thus prevented us from making any moves.

The gearbox spectrum shows an input shaft gearmesh frequency of 0.27 inch per second at 28,800 cpm. This indicates that the bearing on the input shaft has excessive wear and should be replaced and readjusted for proper gearmesh and backlash. Please monitor the vibration level closely and perform a mechanical inspection when the vibration level reaches 0.3 inch per second.

Installed new drive
shaft and couplings.

Aligned Motor, Center
support bearing.
Vib. suggest bad
bearing or loose bear-
input shaft bearing.

Same vib. point
at 5 kHz.

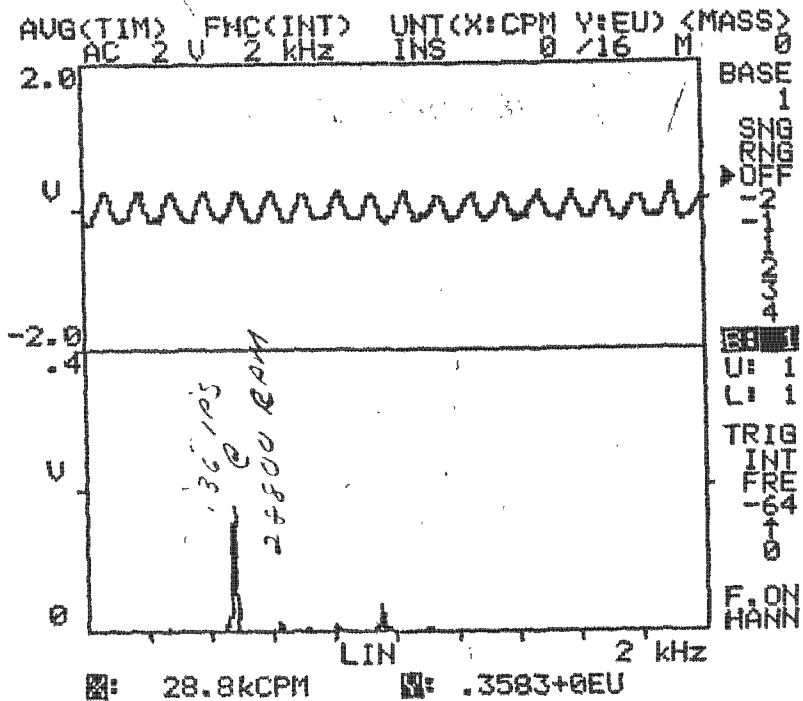
CLIENT NEVADA POWER COMPANY LOCATION REID GARDNER PLOT 5
 NUMBER NO. 4 MACHINERY COOLING TOWER FAN

4.3 COOLING TOWER FAN: CELL "A" Plot no. 5

Cell "A's" gearbox vibration level is considered in the ALARM level. The gearbox should be inspected for bearing condition and proper gearmesh. We found that the drive-shaft coupling gaps were too wide on both drive-shafts. The center support bearing housing temperature was very hot, suggesting that the bearing was subjected to high axial forces.

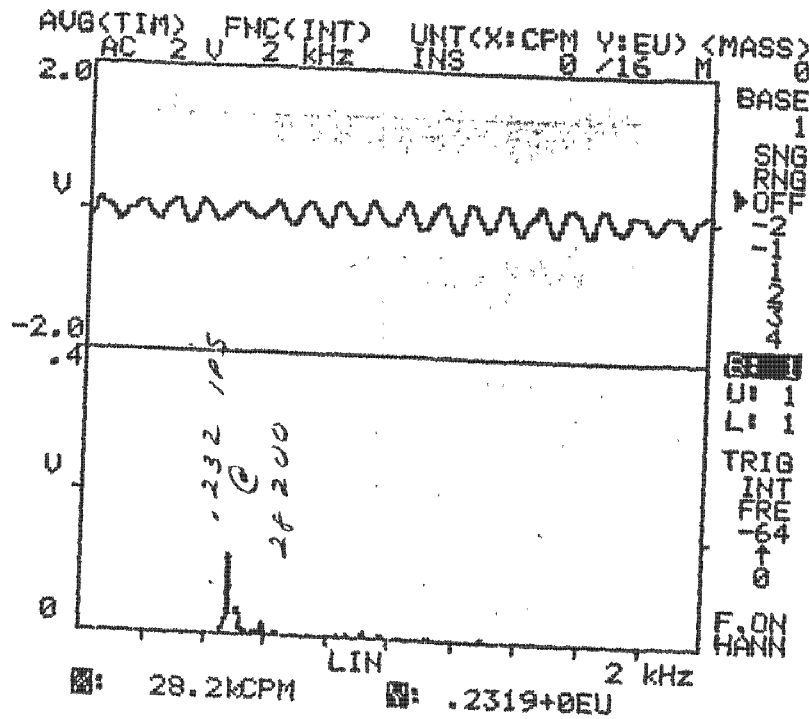
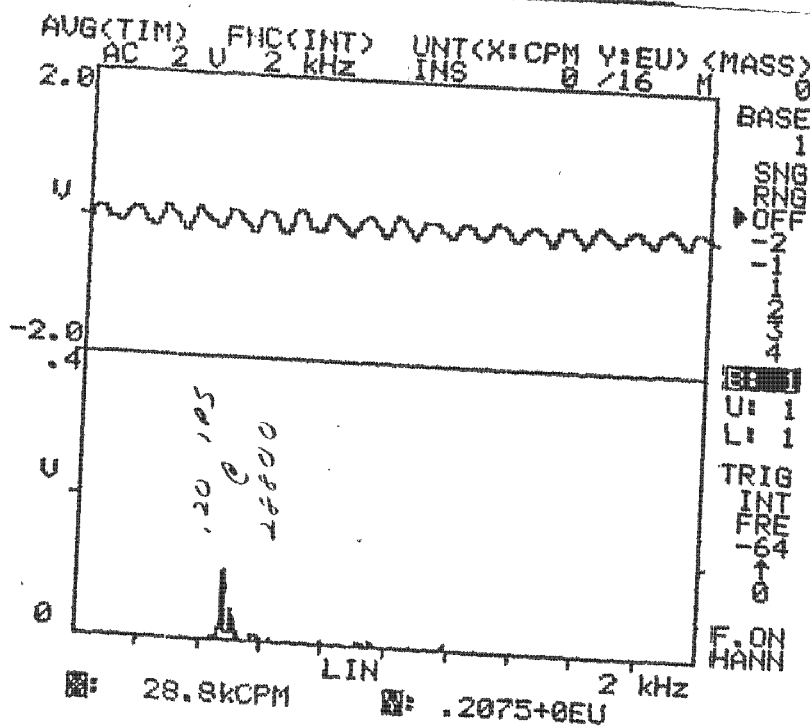
CLIENT NEVADA POWER COMPANY LOCATION REID GARDNER PLOT 6
 NUMBER NO. 4 MACHINERY COOLING TOWER FANS

4.4 COOLING TOWER FANS: CELLS "B, C, and E" Plots no. 5 & 6

The spectrum plots for these gearboxes suggests that these units are running within acceptable vibration levels.

ACCEPTABLE VIB.

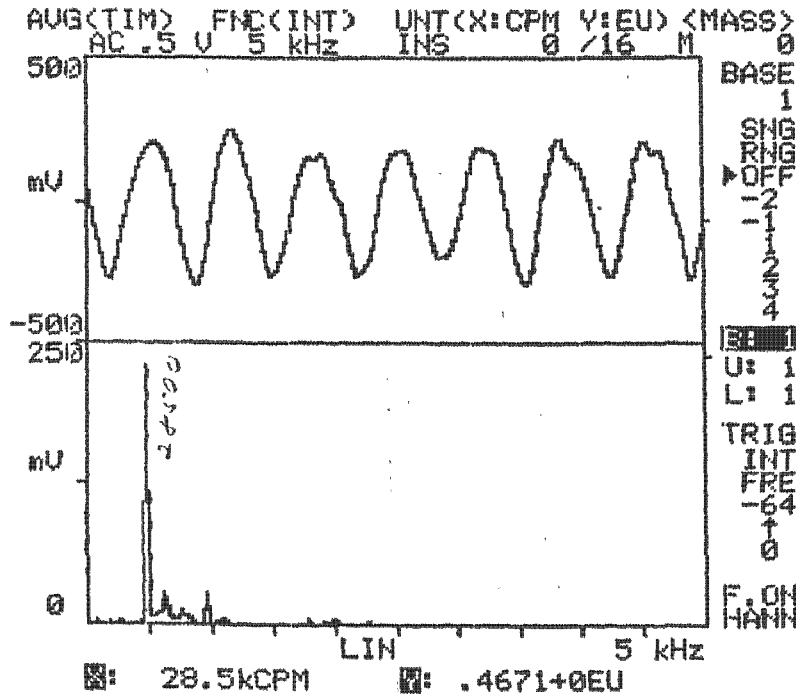
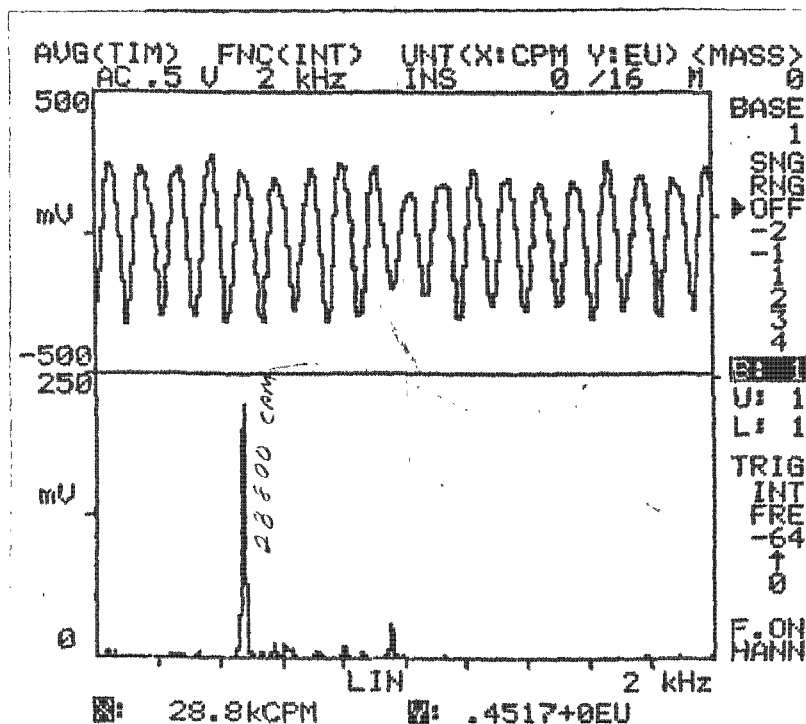
LOCATION REID GARDNER PLOT 11

4.5 COOLING TOWER FAN: CELL "G"

Cell "G's" gearbox vibration levels are considered to be in the ALARM level. The gearbox should be inspected for bearing condition and proper gearmesh. We found that the drive-shaft coupling gaps were too narrow on both shafts. The narrow coupling gaps would cause the drive-shaft to be in constant compression, especially with the thermal growth and thus cause the drive shafts to bow in the center.

I.P.S. .4671

I.P.S. .4517

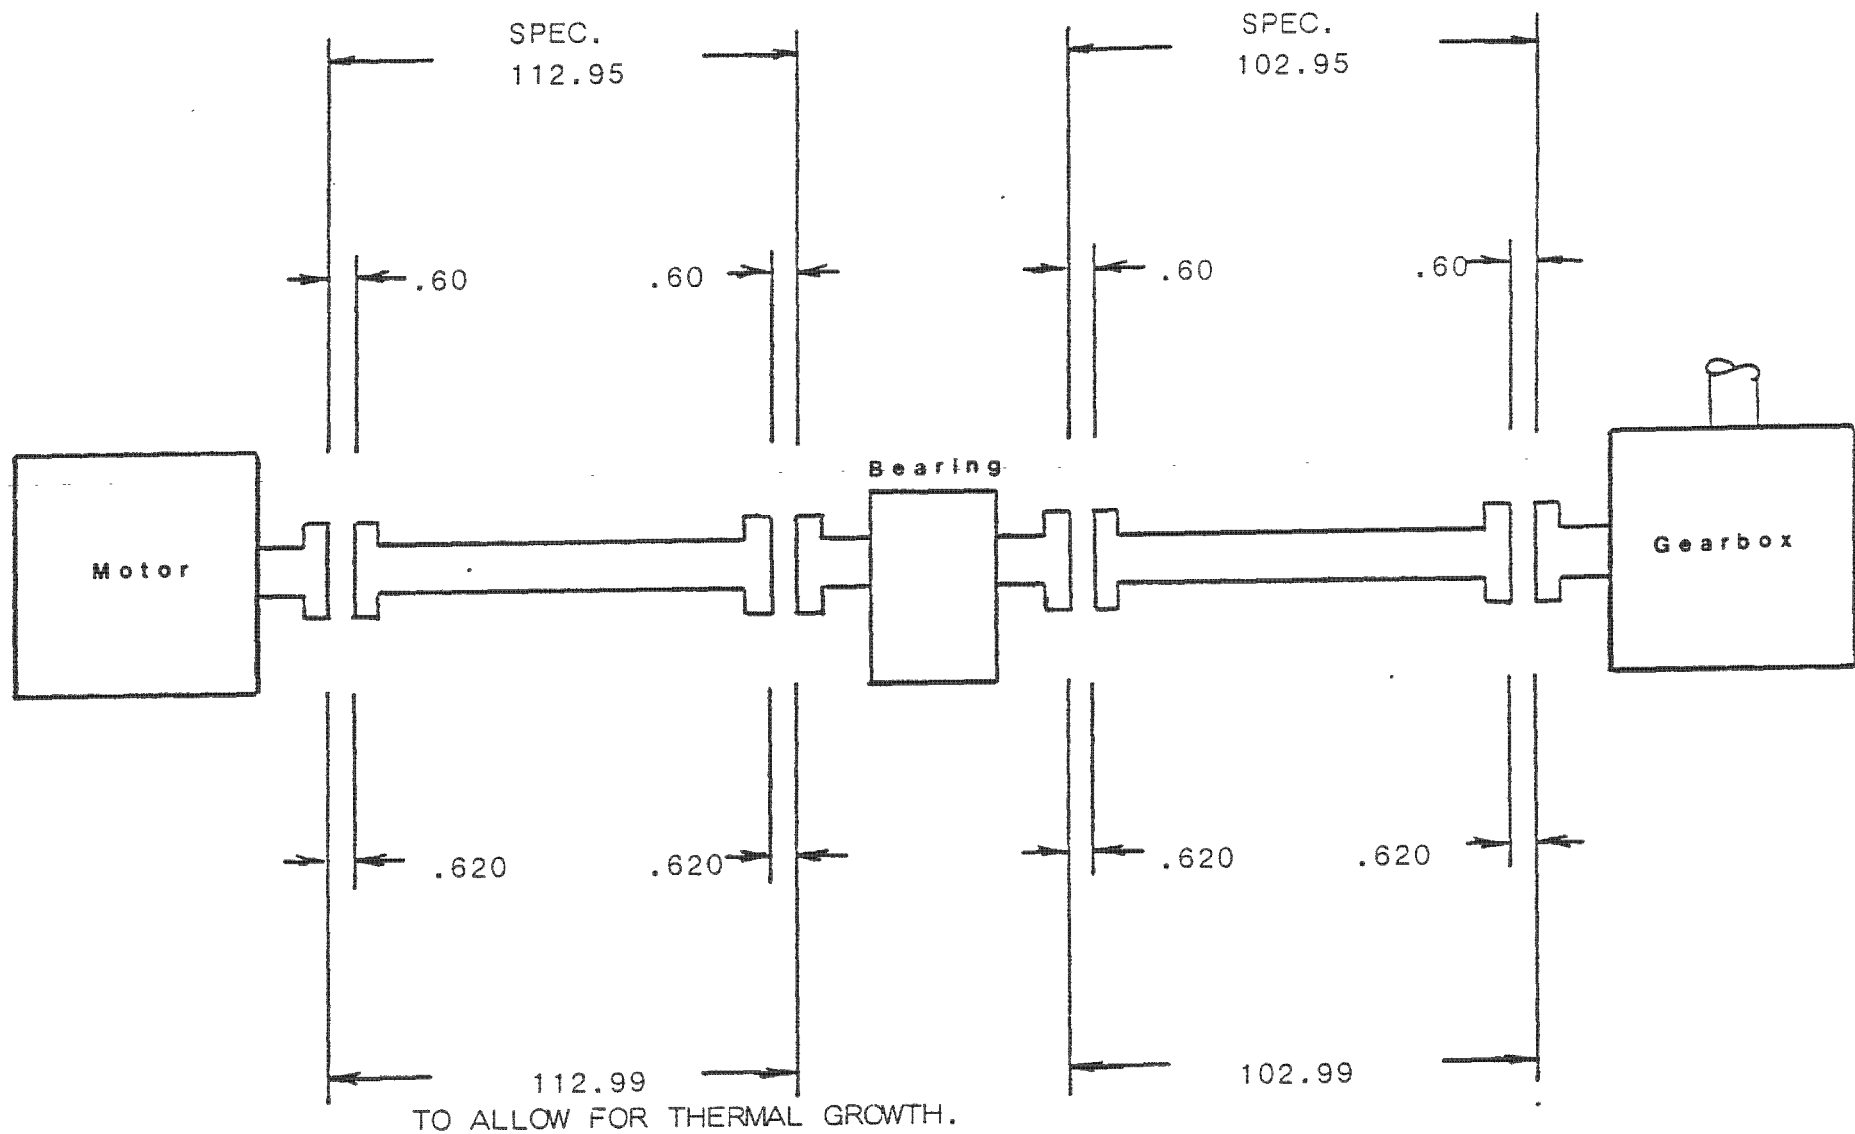
5-1

The manufactures specification for proper coupling gaps are displayed on page 5-1. We have also calculated the cold desired coupling gap based on a thermal growth of 20 degrees F.

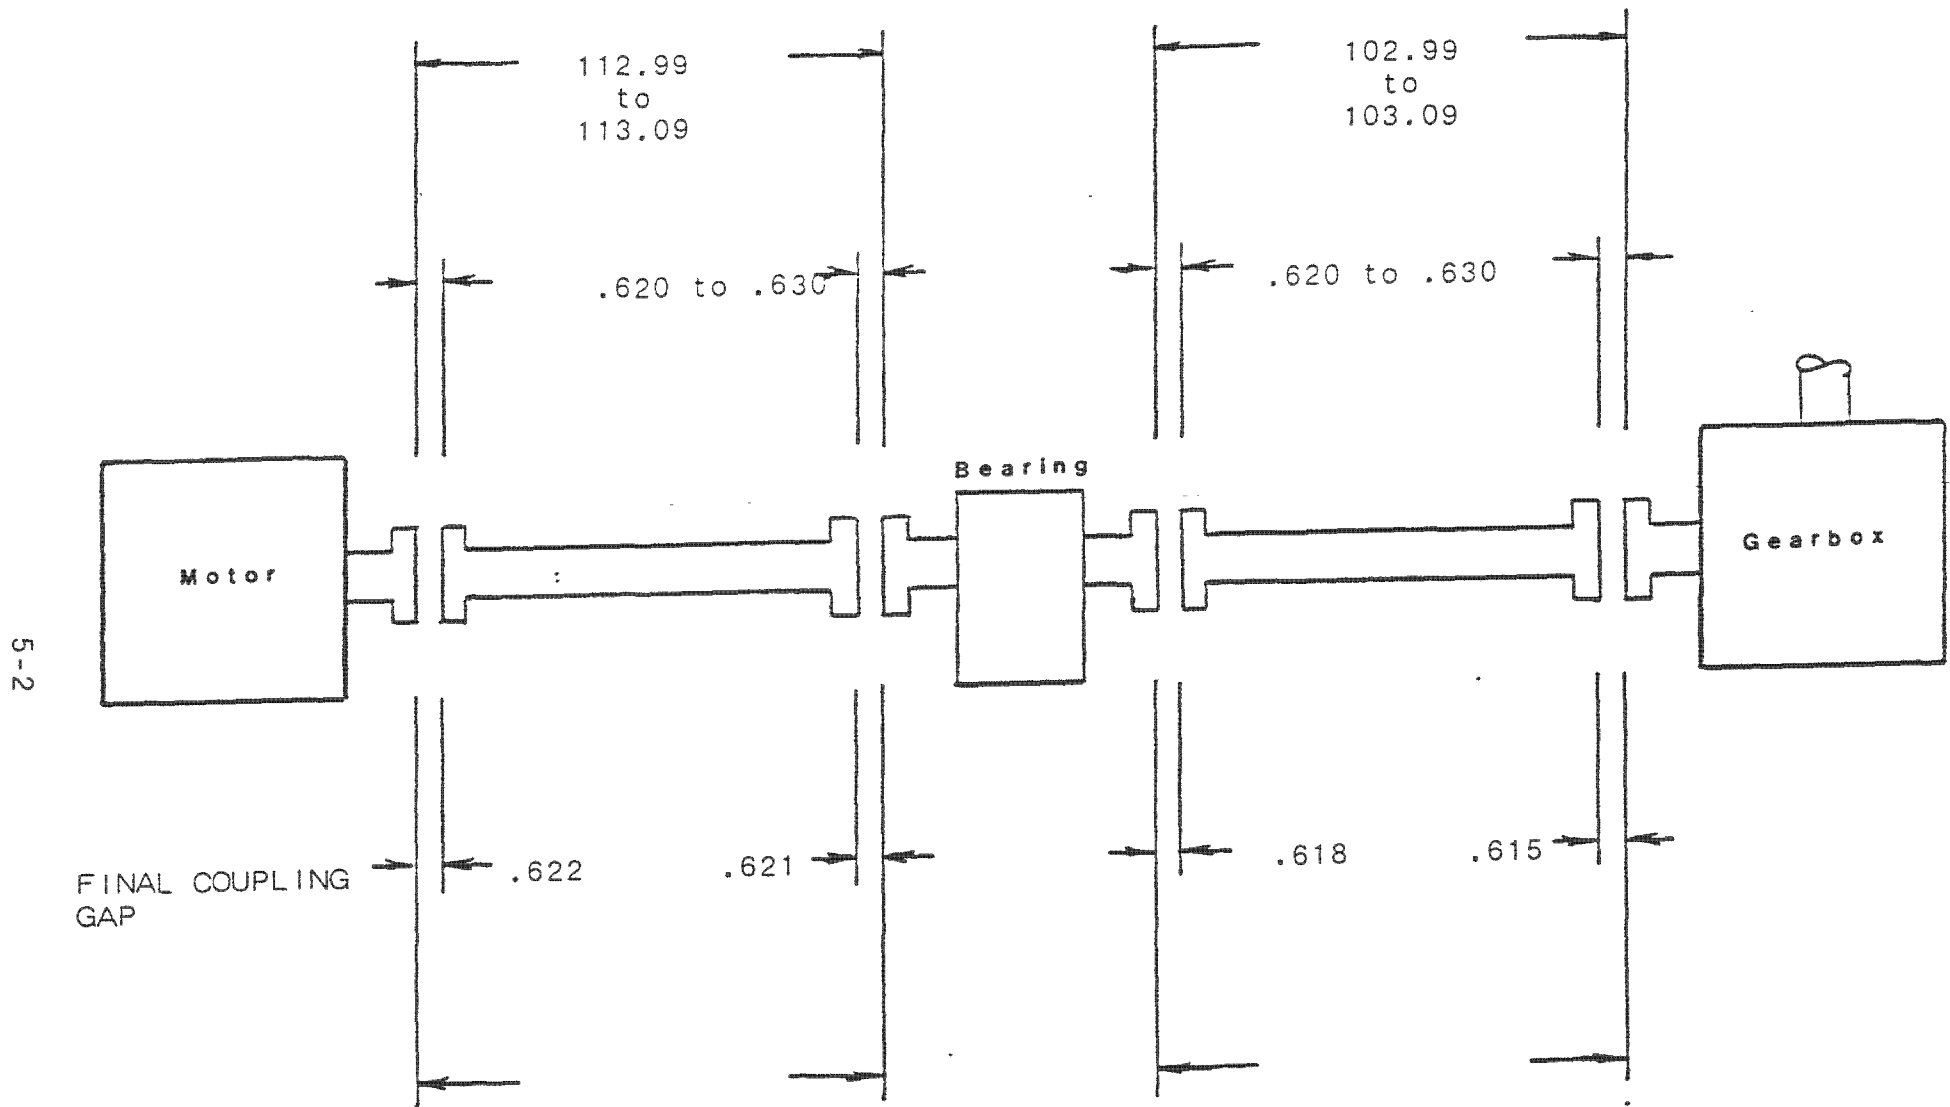
UNIT NO. 4 D

The final cold coupling gaps for Cell "D" are recorded on page 5-2.

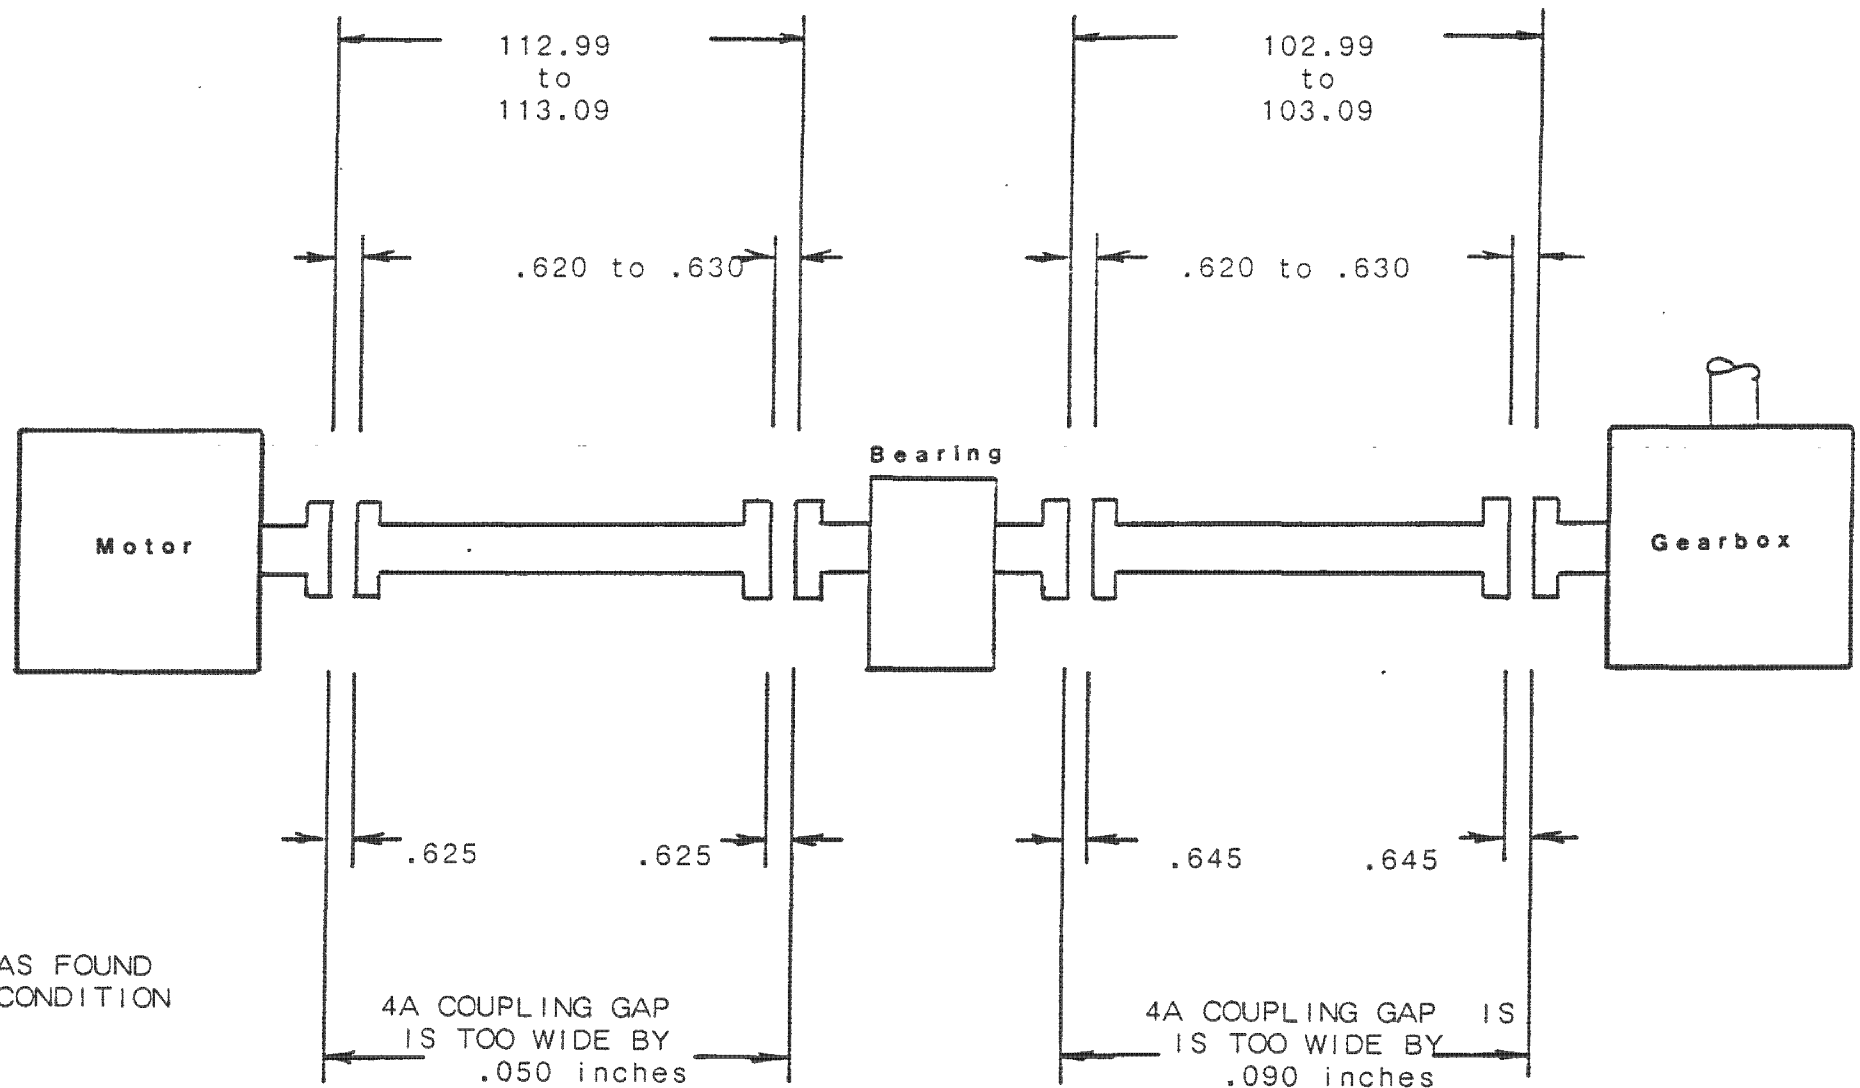
The As Found hot coupling gaps for Cell "A" and "G" are recorded on pages 5-3 and 5-4.

AS FOUND
CONDITION
